Inventorying Culverts in Connecticut

Jasmine Beaty and Brittany Anderson, UCONN, Connecticut Department of Energy and Environmental Protection, DEEP/ Teacher: Thomas Pepe, THS

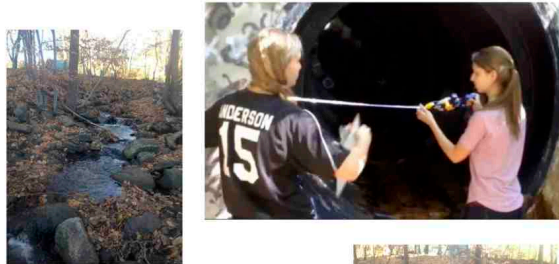
Our methods and procedure for this project were to first identify the town and culvert number. Then, measure the width and length of the culvert. After, we then measured the projection out of the culvert. After all our physical data was recorded we took multiple photographs looking both up and down the stream sides. Photographs are very important to this project because they can tell you whether or not the culvert lets the trout get through, if the culvert is clean or if it's polluted, also they even help explain and clarify your information from the charts.
