The Effects of Re-Establishment of Saltwater to Coastal Wetlands

NRCA Student: Emma L. Gallagher¹
 Community Partners: Dr. Ashley Helton² and April Doroski²
¹Bridgeport Aquaculture School ²University of Connecticut

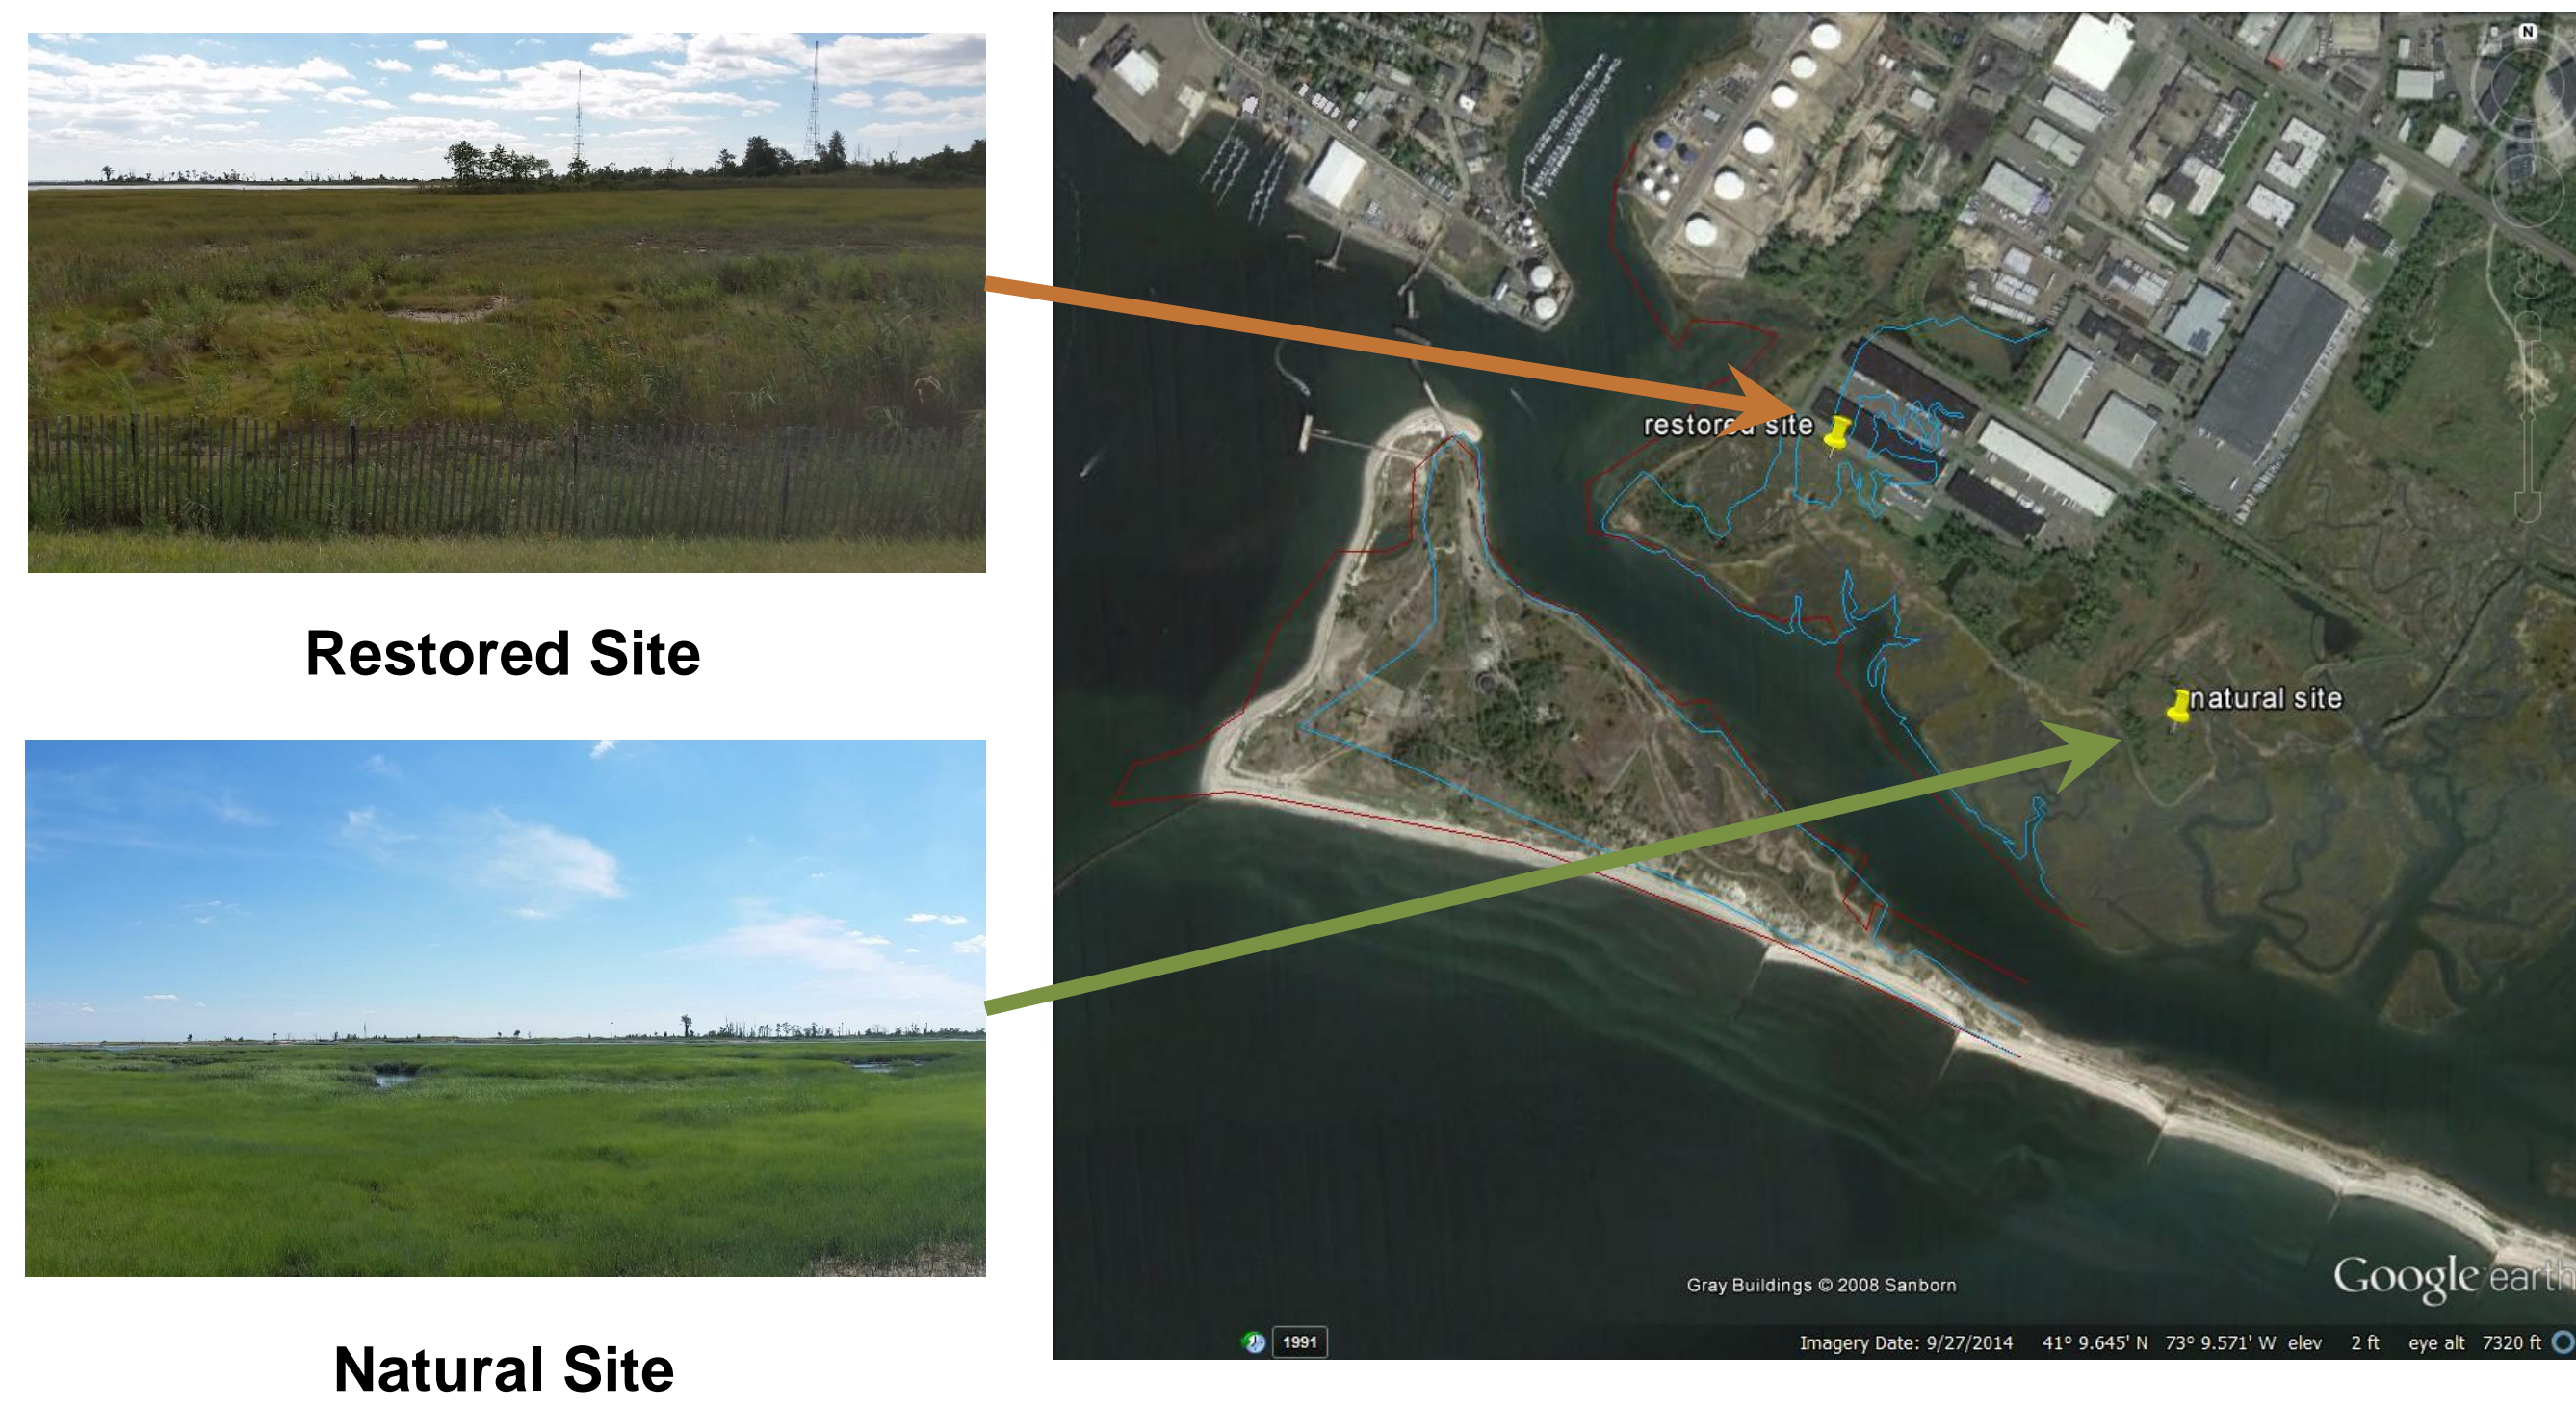
Fig 1. The aerial map displayed above shows the location of the two testing sites. This map includes the coastlines of the area from 1934 (outlined in blue) and 1965 (outlined in red). This shows how the coastline progressed over time.

- The sites are located within the Great Meadows Unit of the Stewart B. McKinney National Wildlife Refuge along the border between Stratford and Bridgeport, CT.
- The samples were taken from within a ten acre section of the site restored between September 2003 and March 2006. The restored area is located adjacent to industrial buildings and roads.
- Identical samples were taken from an unrestored natural wetland area nearby, located further in the woods (Fig. 1).

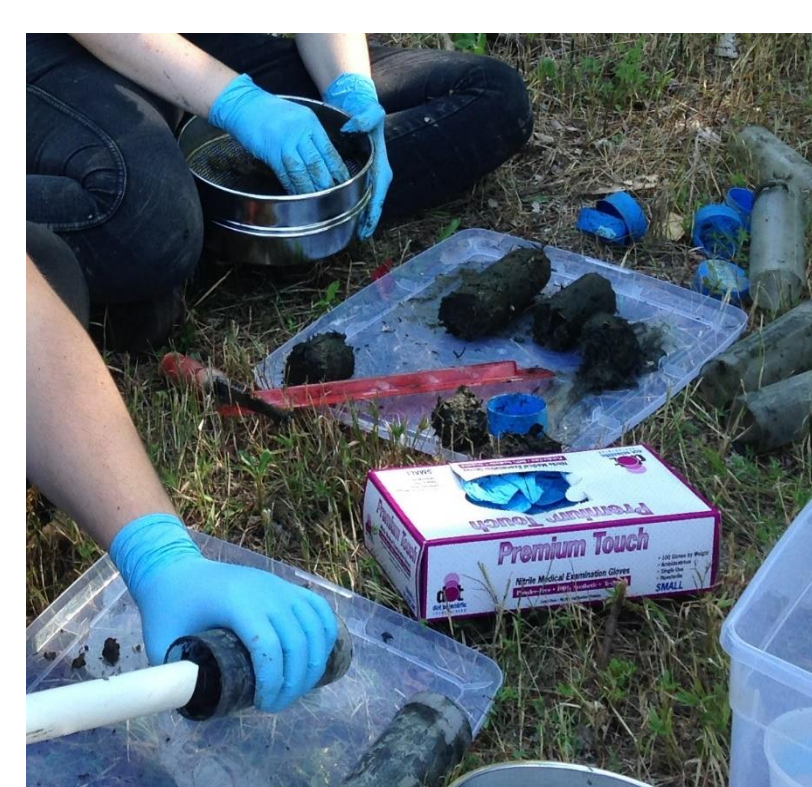
Fig 2. (left) Soil cores being processed and examined onsite.

- Four trips were made to both sites to collect soil, plant, and water samples from August to November of 2015.
- 3-4 soil cores were collected from different areas of each site and sifted together to homogenize the samples, and large roots and other impurities that would impede the investigation were sifted and extracted onsite (Fig. 2). The contents were later analyzed in a lab for water content, organic matter content, and metal concentrations.

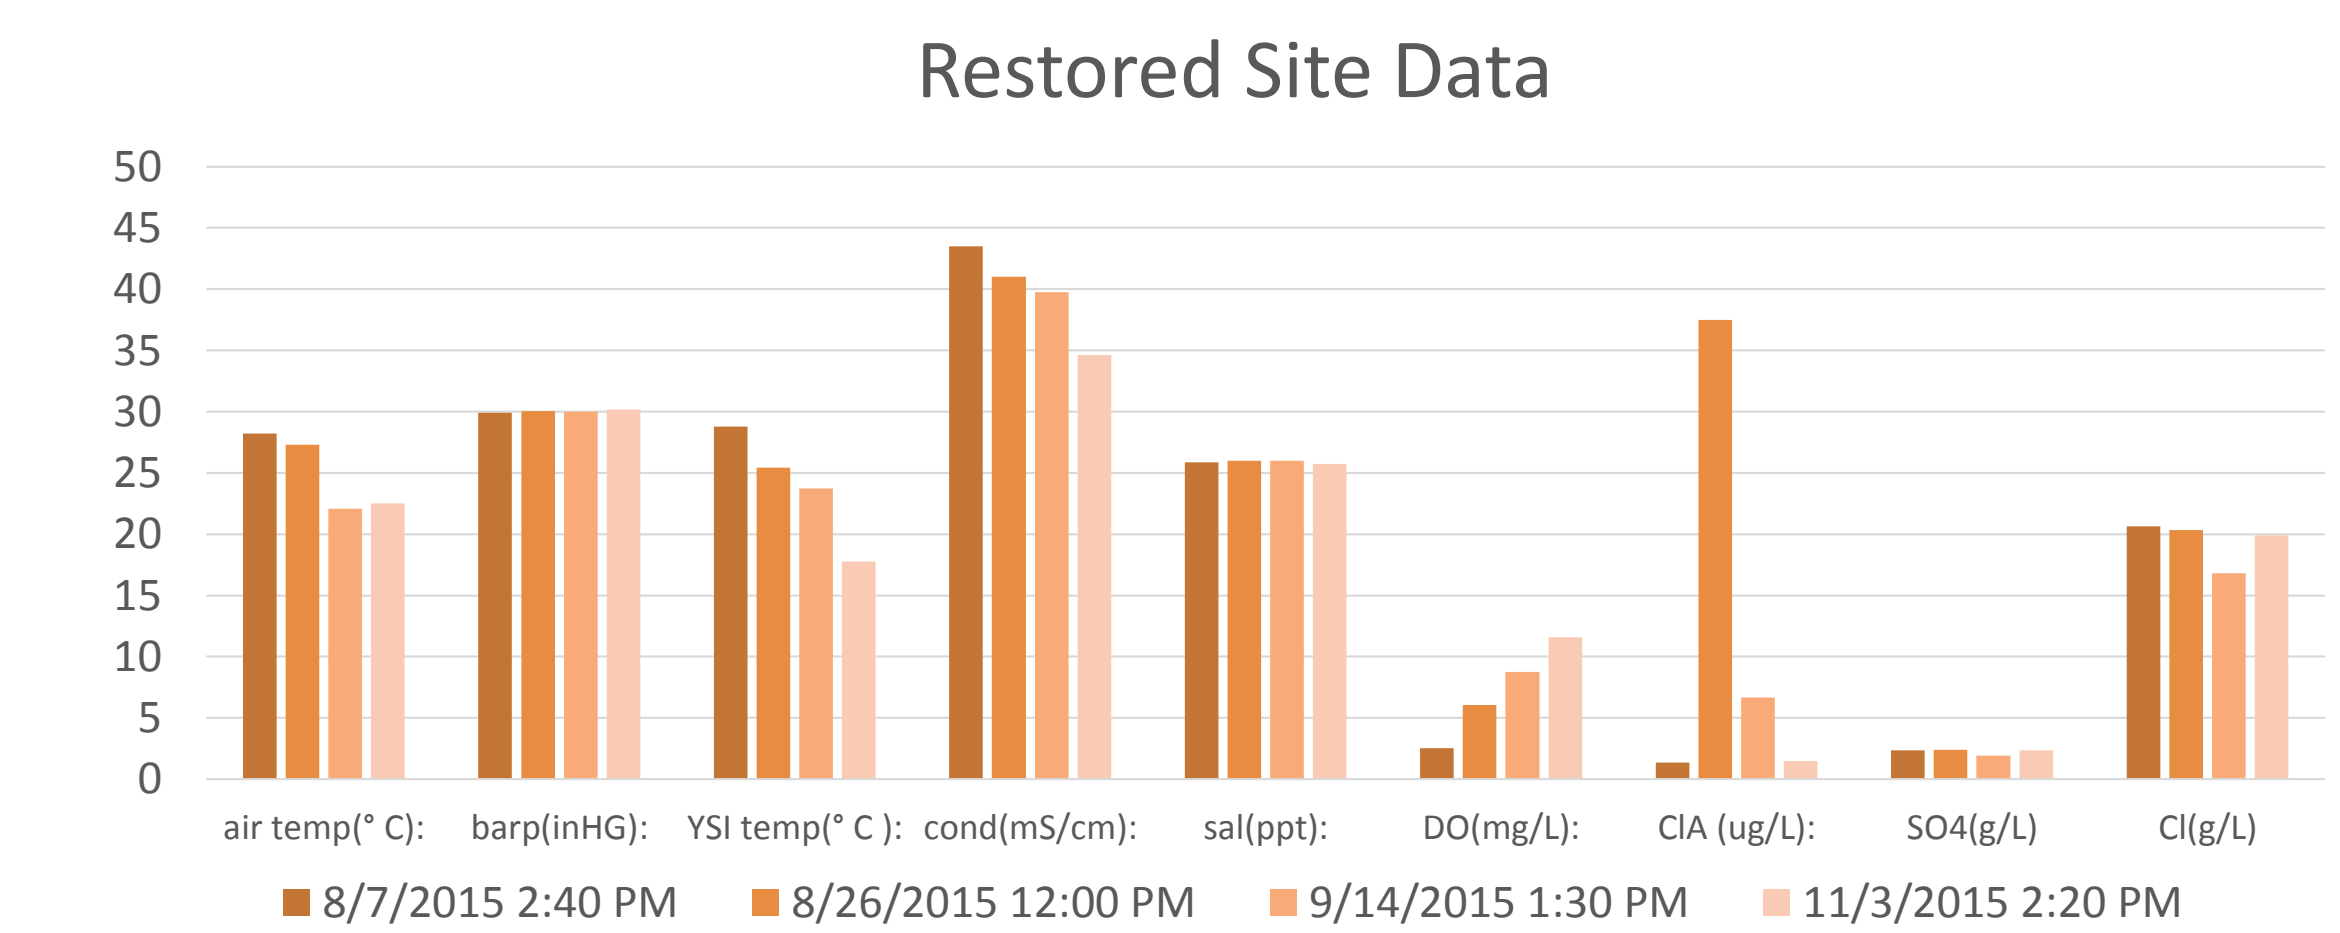
Fig 5. This graph depicts the data collected from the restored site on all four dates.

- The soil in this site was fairly low in phosphate compared to the natural site, with 0.1 mg/L compared to the natural 1.3 mg/L. There were low levels of nitrate detected, which could be due to iron interference. Much of the soil was an orange-red color due to high iron levels.

- The channel here appeared to be smaller, and was difficult to find the majority of the time. It also appeared fairly murky, and contained low levels of chlorophyll A.

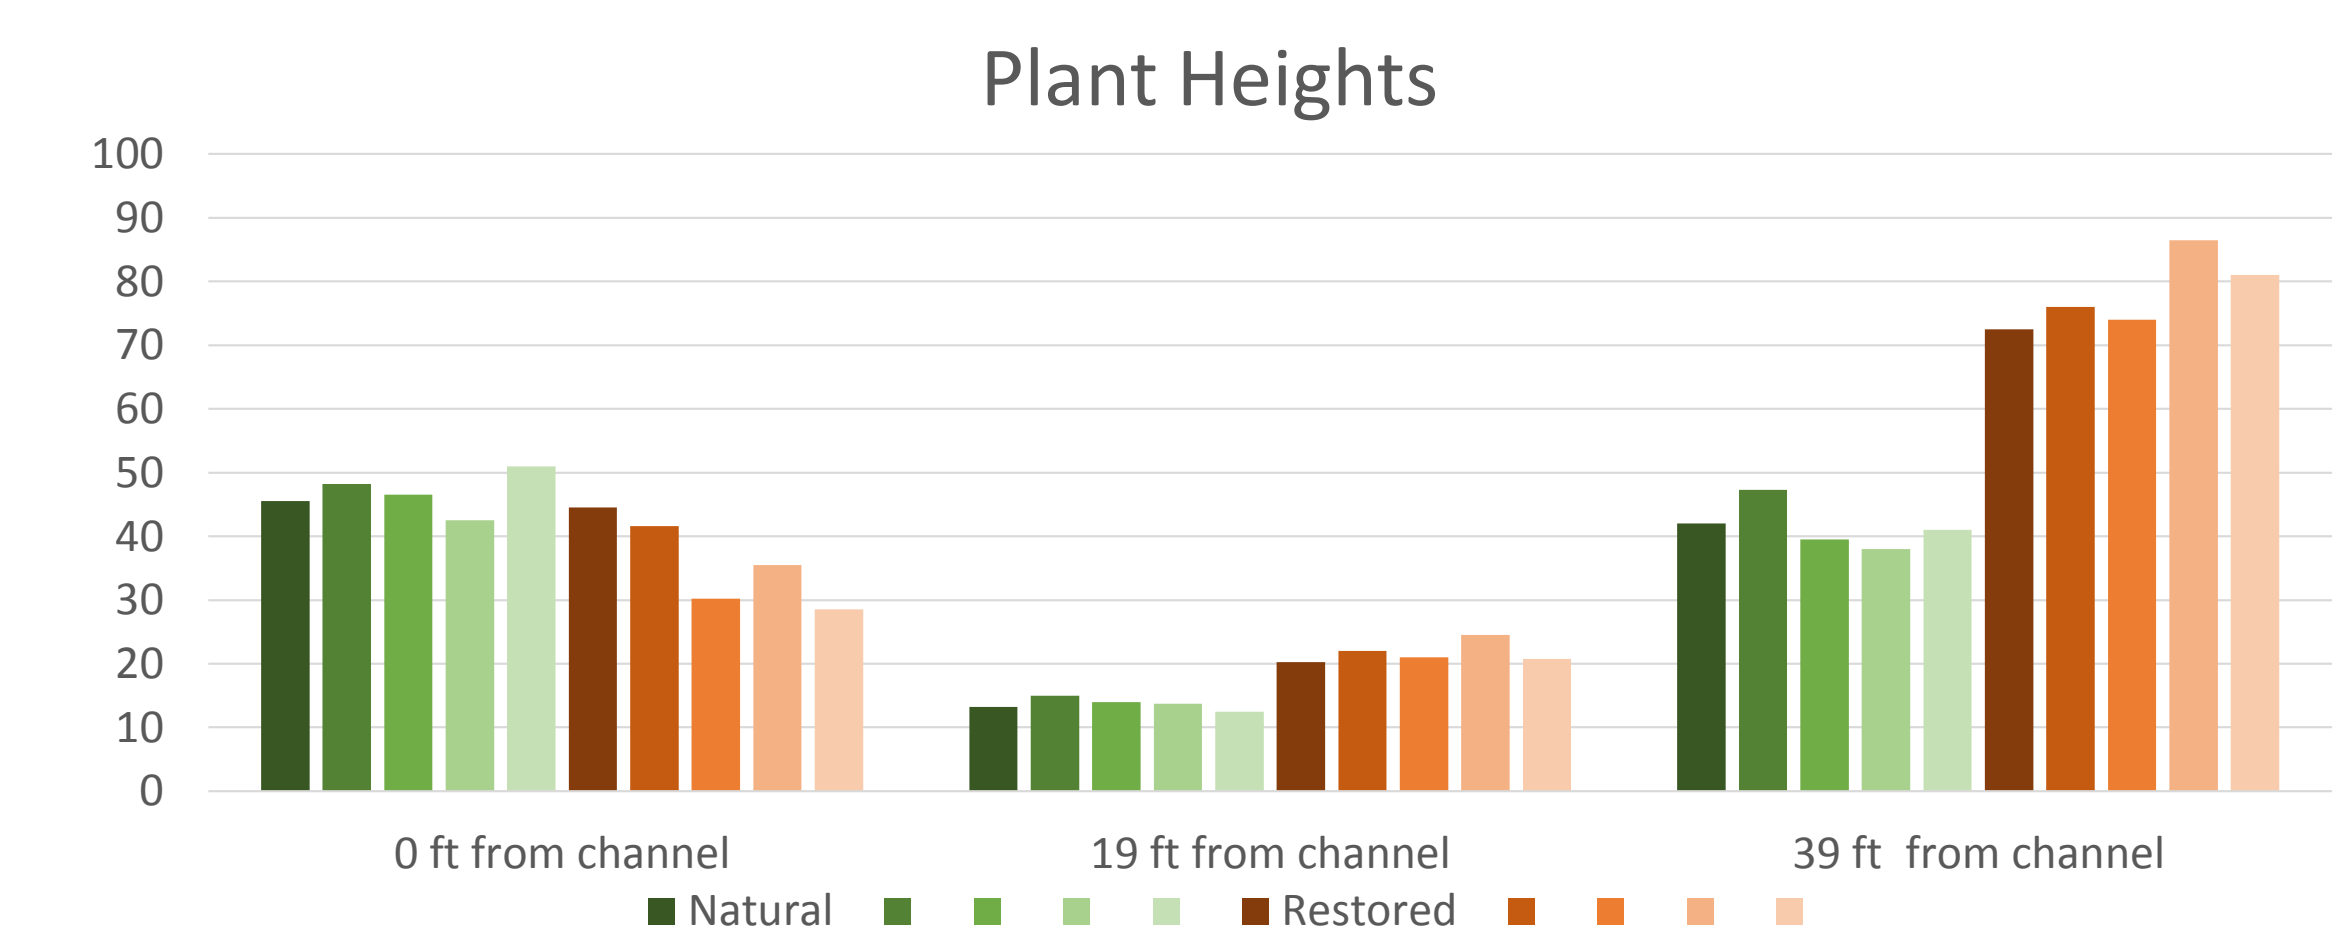
Fig 6. This graph shows the tallest plant heights in a square meter radius, certain distances from the channel at each sample site.

- Plant height was measured along a 50 meter transect with a 0.25 m² quadrat. Quadrat data were collected at 0, 19.5, and 39.5 meters. The plant height was averaged by collecting the heights of the 5 tallest plants in this square radius. Other observations of plants were made, such as plant species and condition.

- The plant life was different from the natural site, with longer grasses, less diversity, and plants such as *Spartina Alterniflora*, or Saltmeadow Cordgrass. Many of the plants had a browner and sparser appearance in comparison to the lush grasses of the natural site. Much of the area was taken over by the invasive Common Reed as well. This species appears mostly on the outskirts of the marsh, roughly 40 ft. from the channel. The plant heights measured show how both locations have different plants, all with different heights (Fig. 6).
