NRCA Student: Jake Lawlor¹

¹Cheshire High School; ²Cheshire Land Trust; ³Quinnipiac River Watershed Association

ABSTRACT

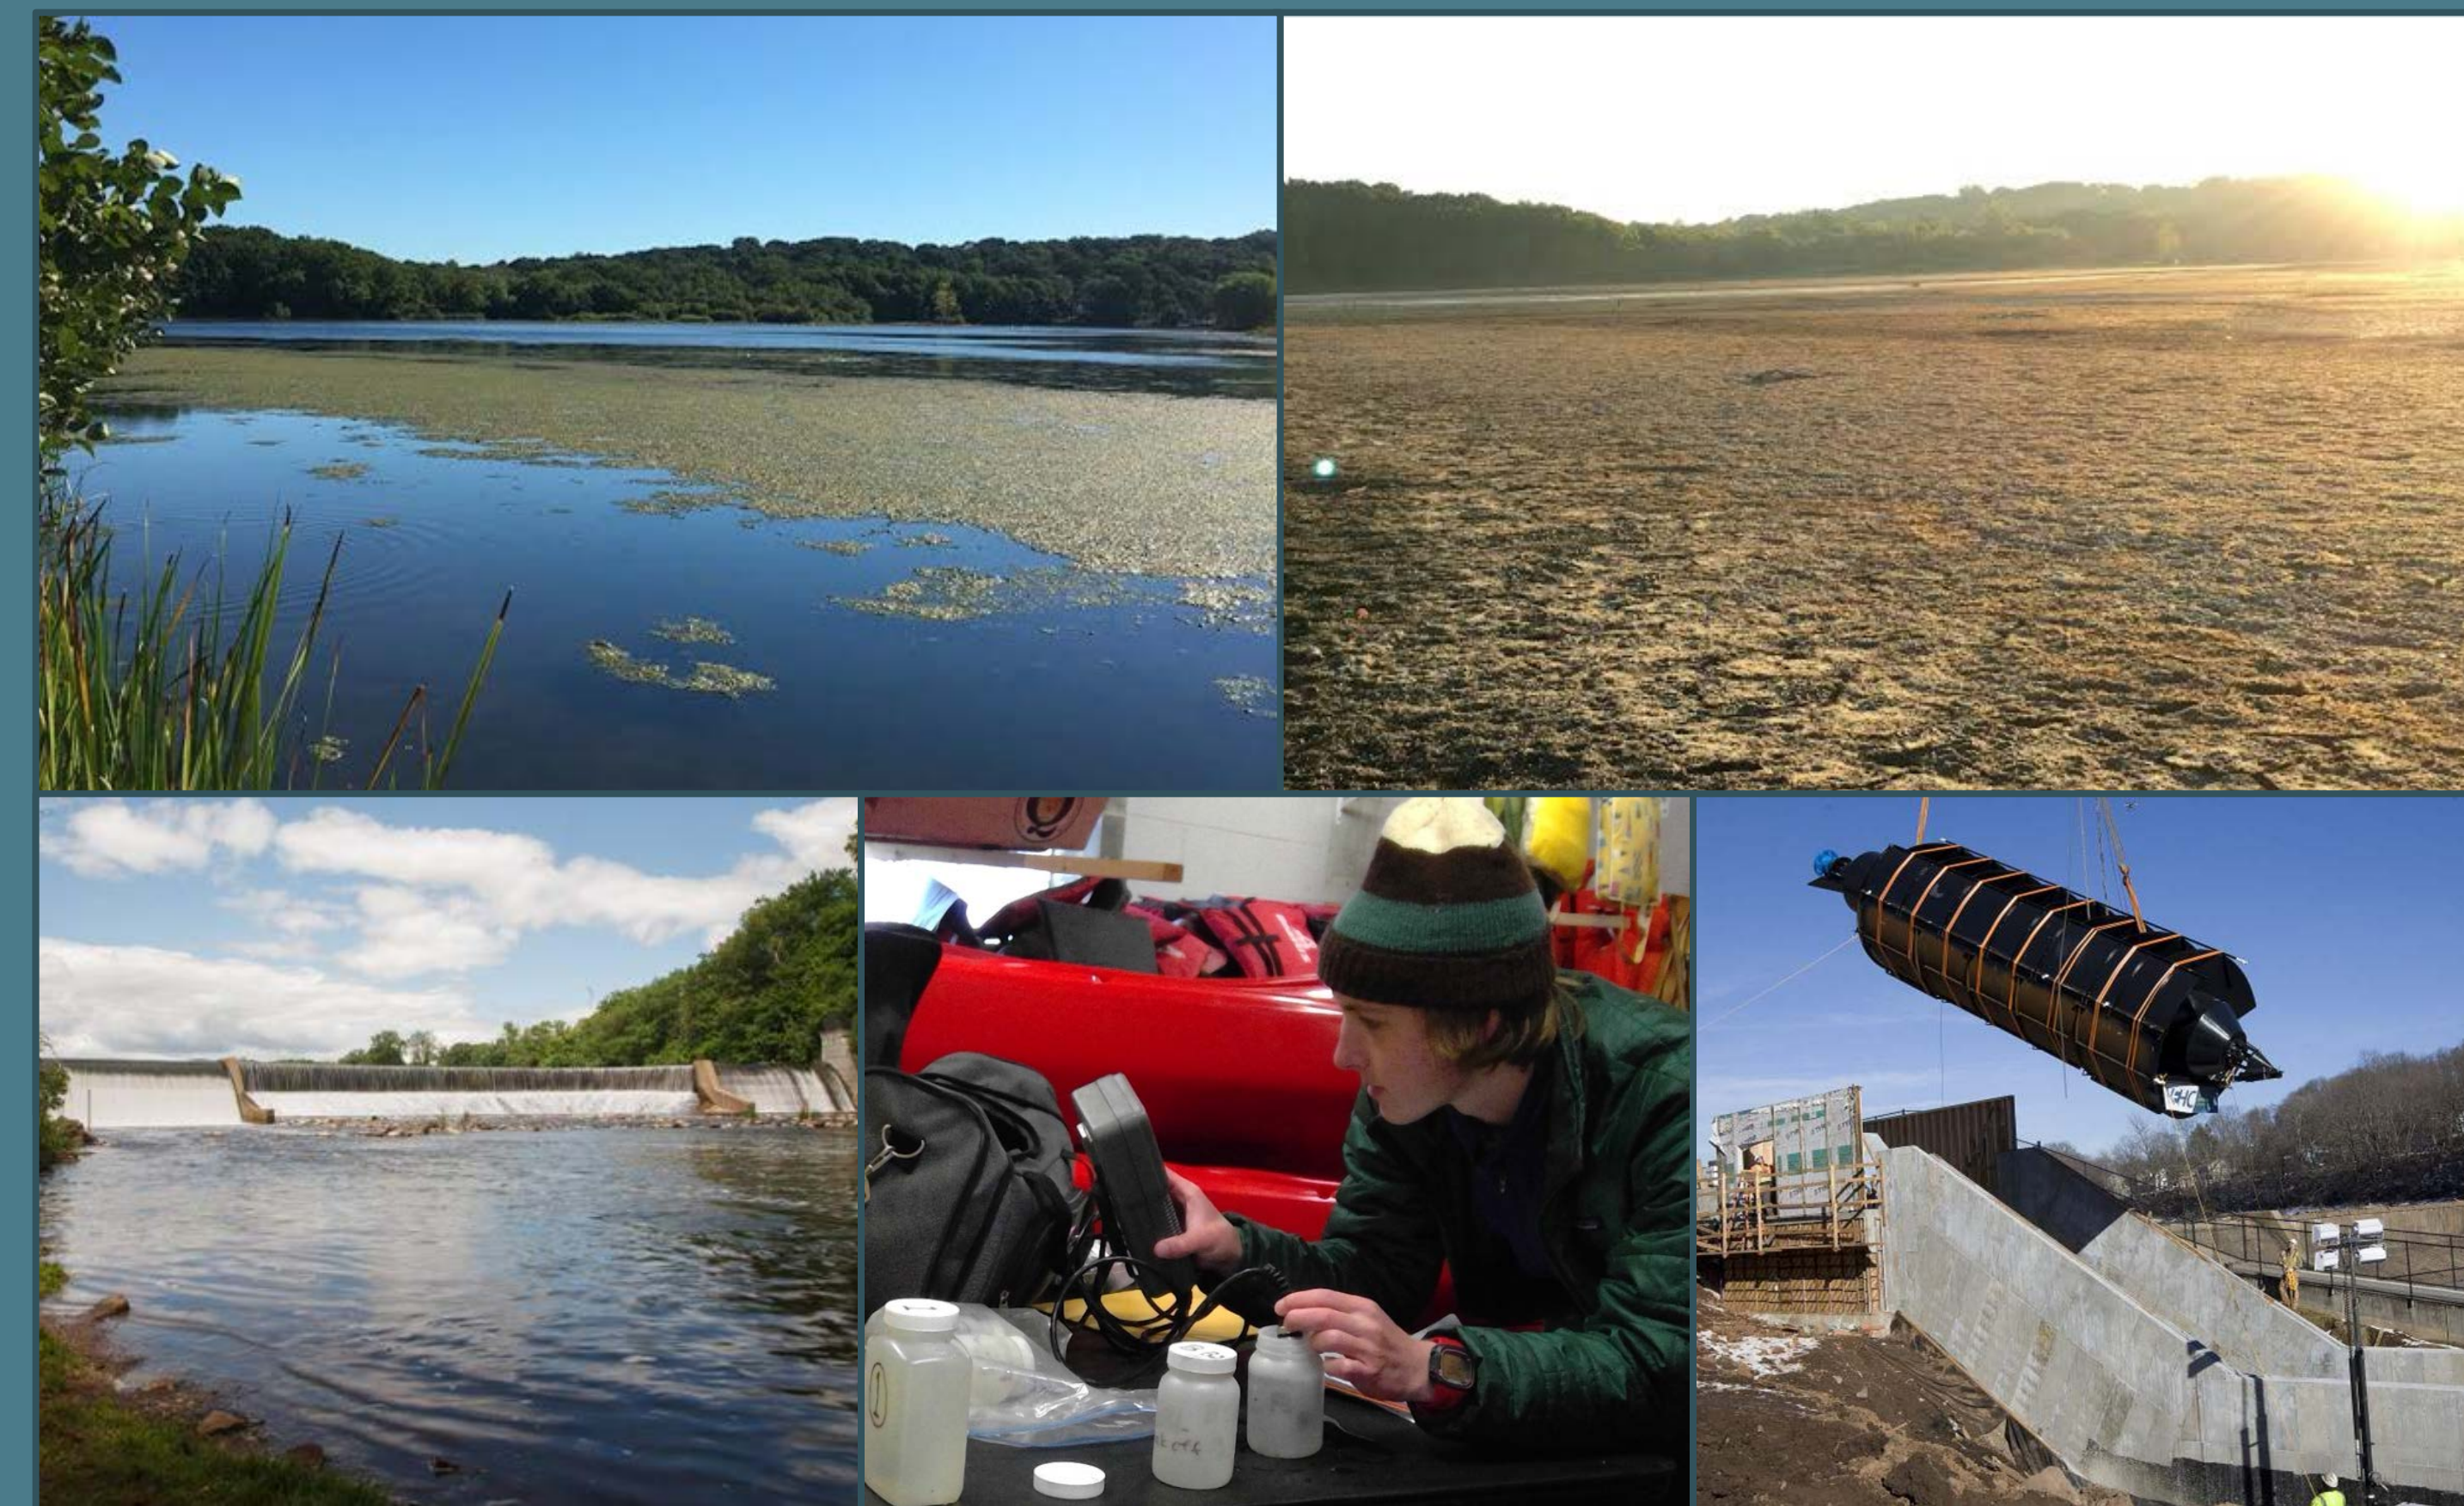
Fig 2. (Top Left) Hanover Pond before drawdown. (Top Right) Hanover Pond one week after drawdown; the pond was reduced to two major pools of water and two small, shallow streams. (Lower Left) Former dam at Hanover Pond. (Lower Middle) Taking water quality measurements using a YSI. (Lower Right) Construction of the Archimedes Screw hydropower dam, which was the reason for the drawdown.

Drawdown was used in Hanover Pond—a 70 acre man-made pond that is a part of the Quinnipiac River watershed—in Meriden, CT (Fig. 1). It is inhabited by many species of birds, drawing the attention of many birders. In September 2016, six vertical feet of water were drawn out of the pond via the opening of a dam, for the purpose of a hydropower project (Fig. 2). Concerns were voiced by the community about potential harm to wildlife that inhabit the pond.
