LARGE WOODY DEBRIS: INFLUENCE ON WATER QUALITY & BANK VEGETATION IN

THE POMPERAUG RIVER

NRCA Student: Maddy Albee¹

¹Newtown High School; ²Audubon Center Bent of the River

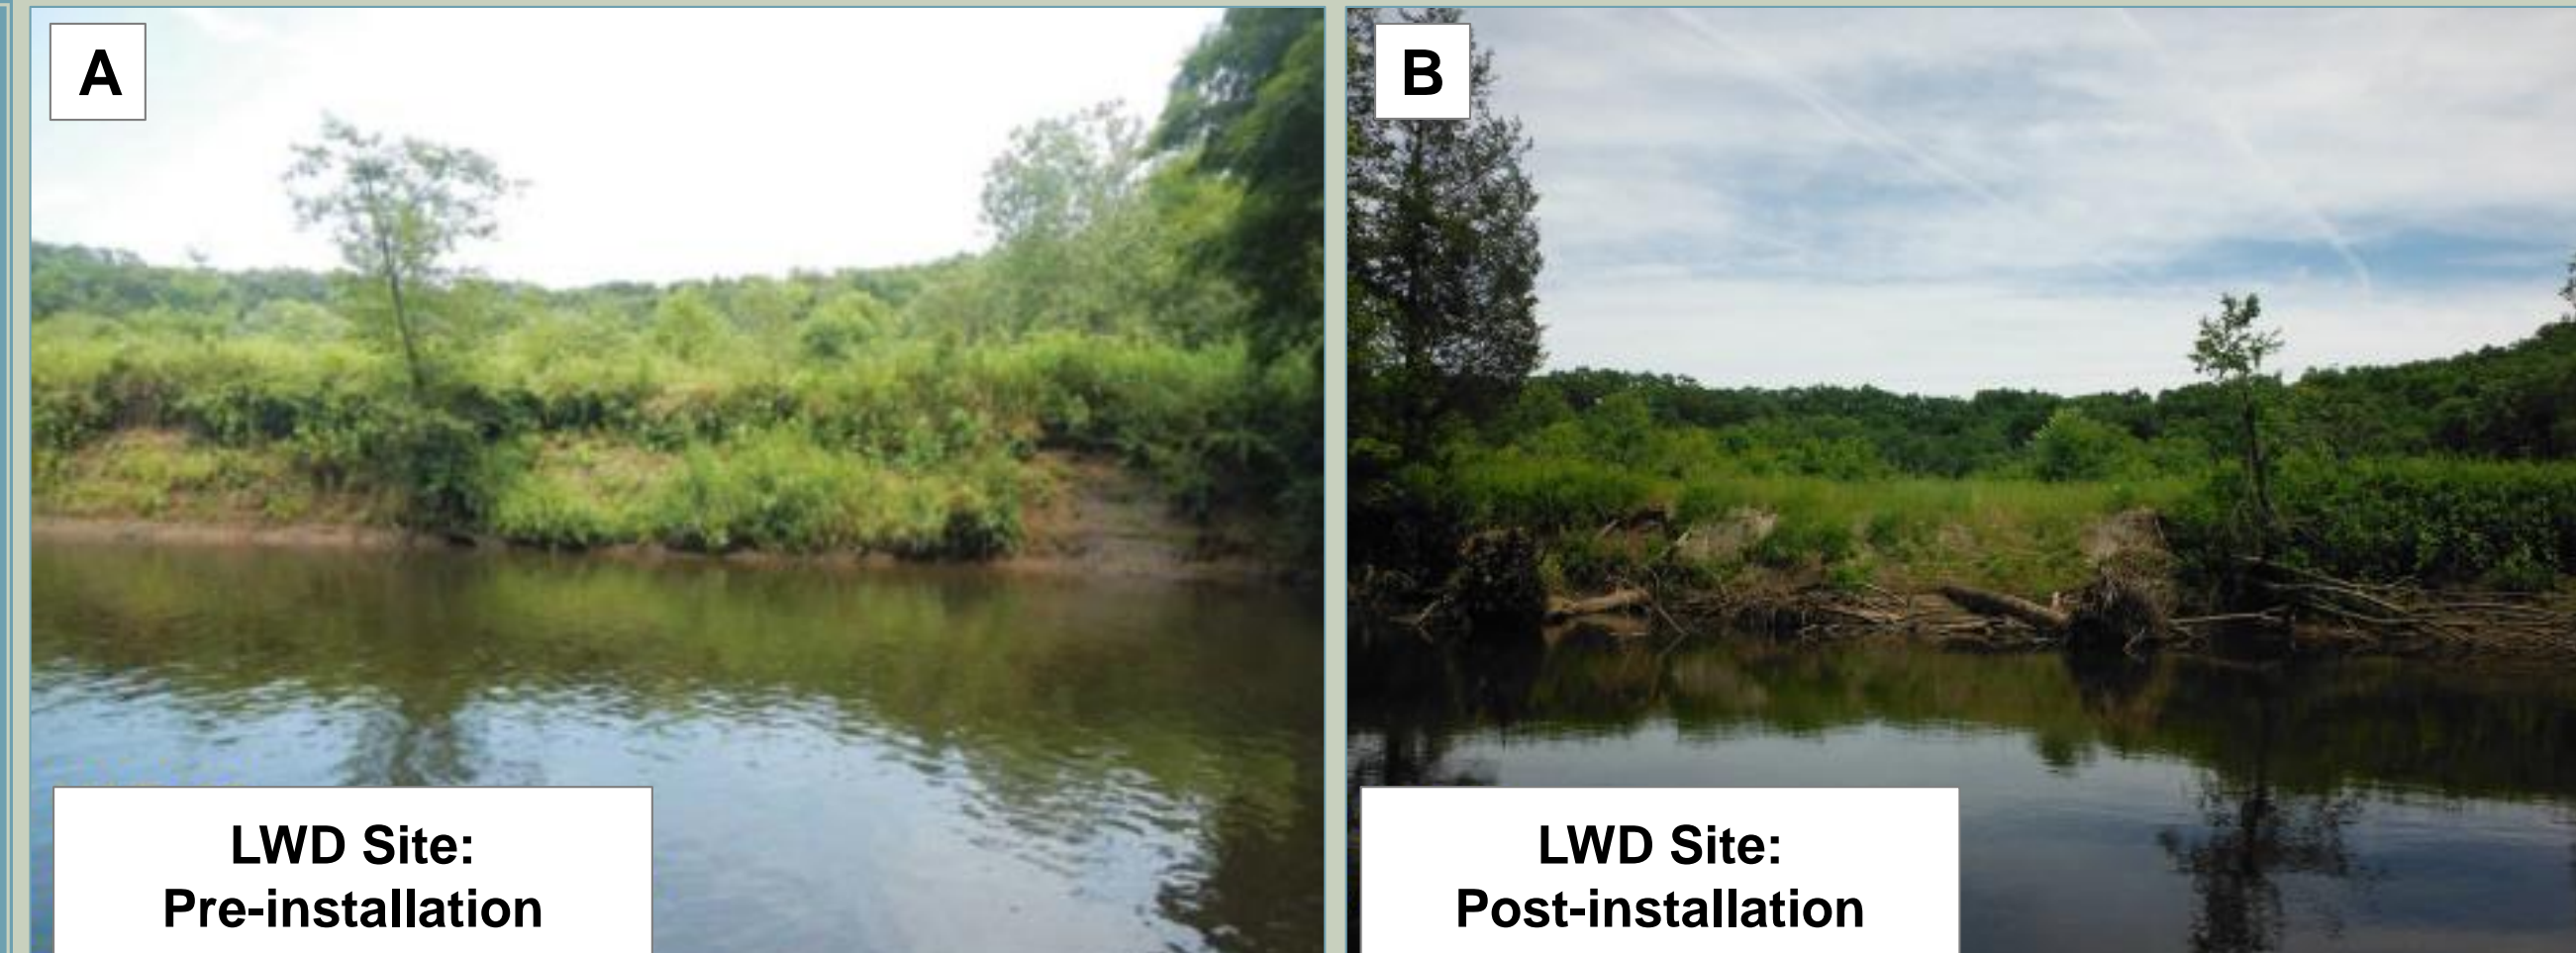
Fig. 1: The study site (A) before the large woody debris (LWD) installation—which was selected because it was a channelized river with eroding banks—and (B) after the LWD installation.

Many rivers in Connecticut (CT) have been channelized for agricultural purposes (1), and the Pomperaug River in Southbury, CT, is no exception (Fig 1A). This results in loss of structural complexity in the river, increased erosion from water flow, and increased water temperature due to lack of shade and lower water levels (2), all of which impacts biodiversity. In addition, pollutants may concentrate due to the lack of riffles, which ultimately poses a threat to the health of freshwater life (1).

In 2014, the Bent of the River Audubon Center (BOTR) installed 10 large woody debris (LWD) sites in the Pomperaug River (Fig 1B). LWD sites consist of large trees including root systems which are anchored into the ground. The goal of the installation was to change streamflow promoting deep pools, circulating cold ground water, creating habitat and acting as flood control.

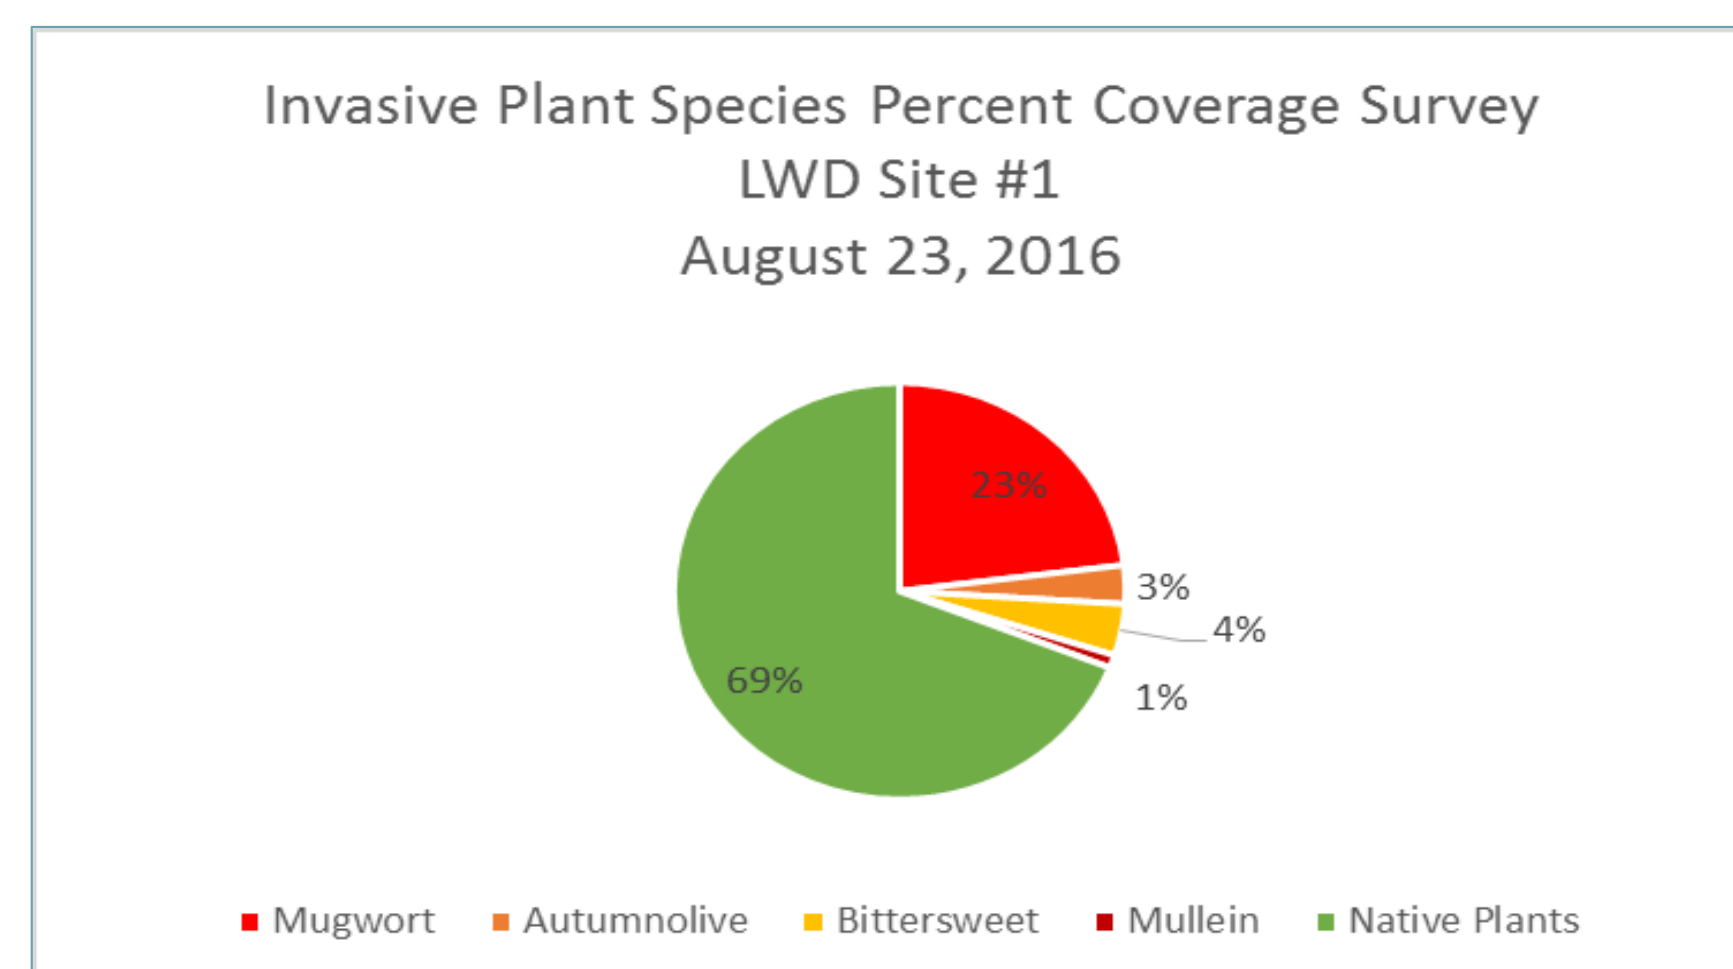
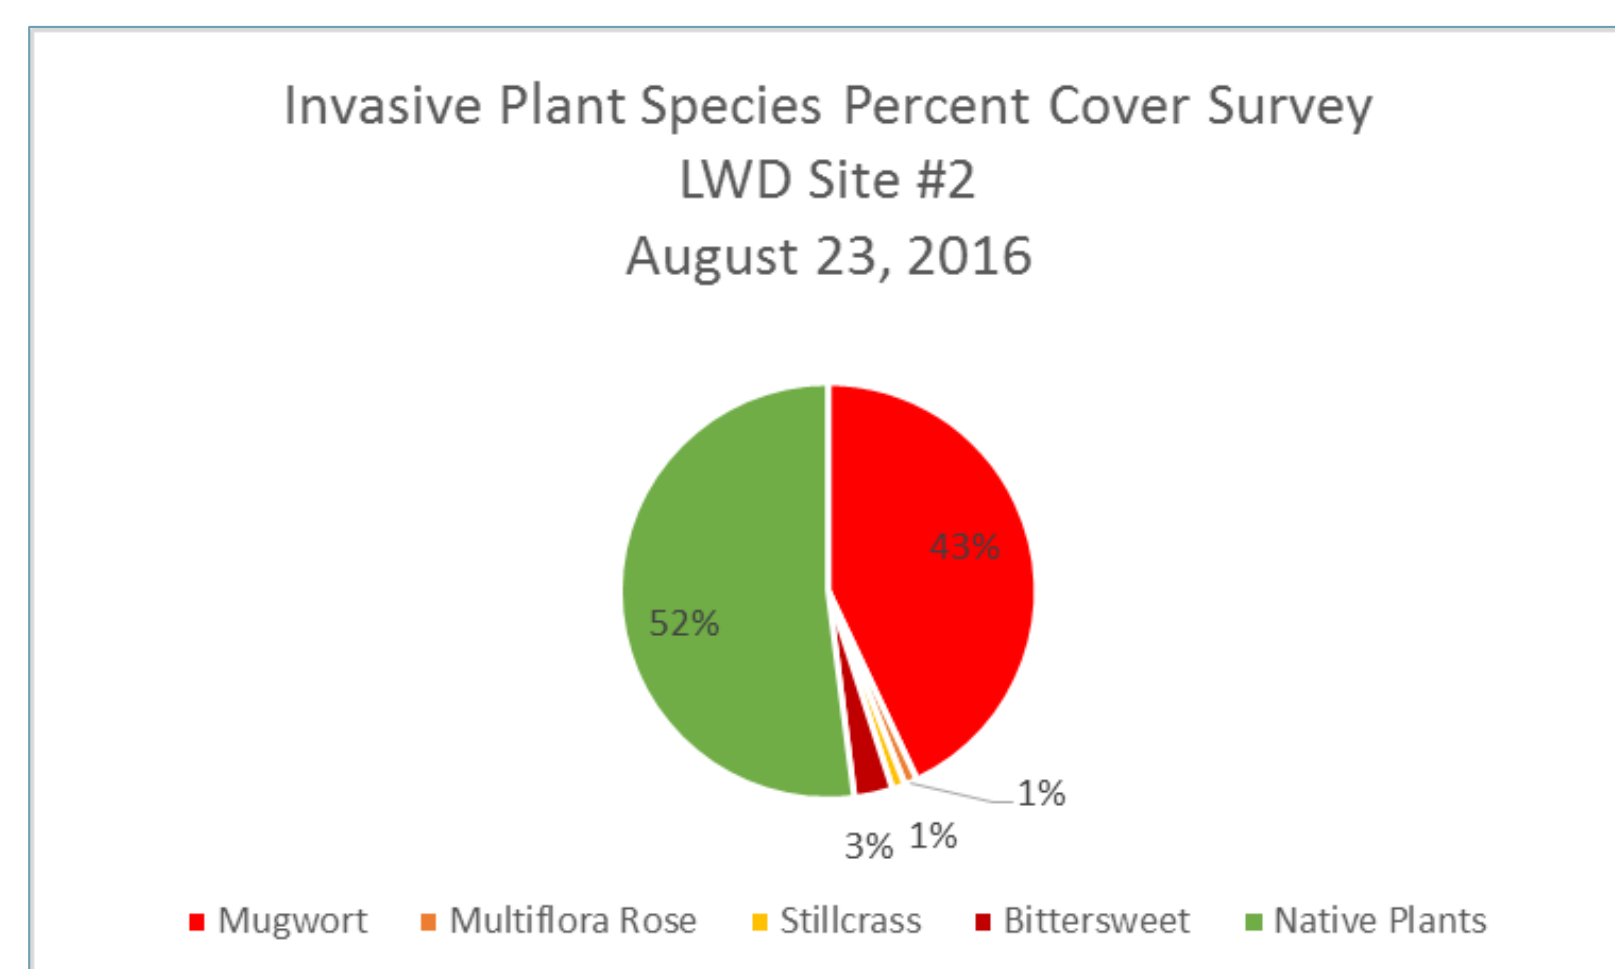
Fig. 2: Percent cover of each invasive plant species and native plants collectively within 15'x15' plots next to two LWD sites. At both sites 4 invasive species were observed and occupied 30-48% of the plot.

- Plant surveys revealed a significant proportion of the bank was occupied by invasive species near LWD sites (Fig. 2).
- Both sites had a prevalence of mugwort.

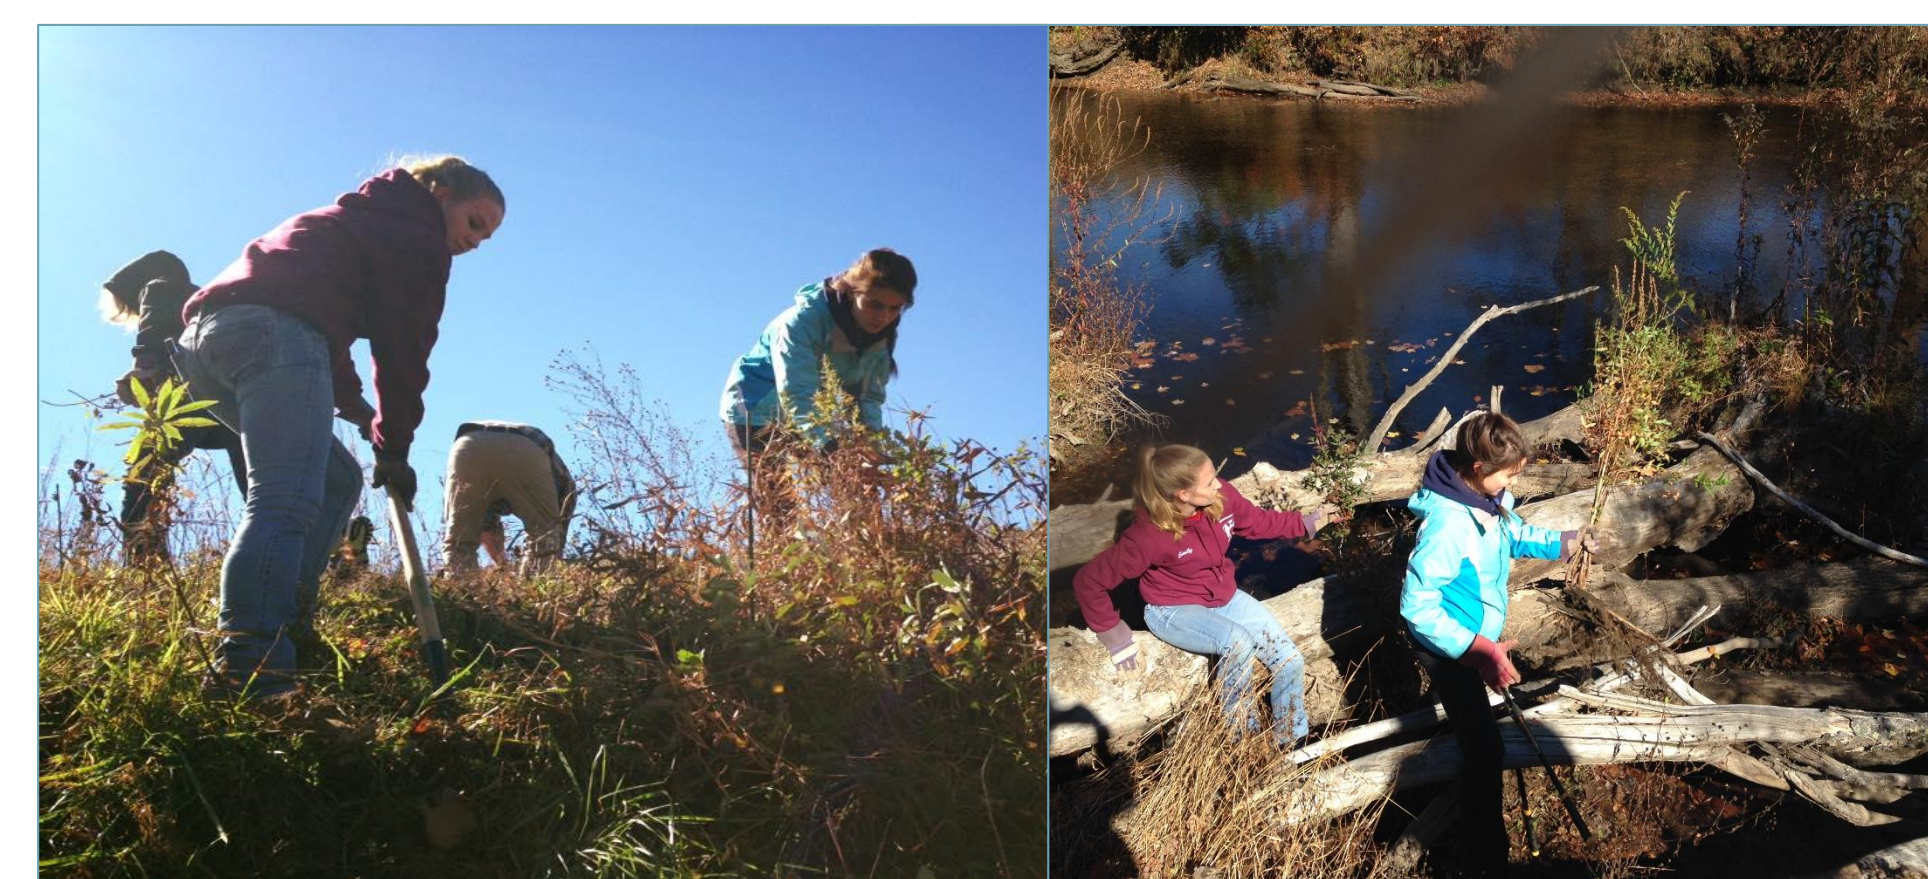
Fig. 3: Photos to the right show the removal of invasive plant species around LWD sites. We dug up/hand pulled mugwort, mullein, and autumn olive, and clipped purple loosestrife (not included in plot results above) off of the stump of one of the LWD sites.

- Given the significant prevalence of invasive plants near LWD sites, I organized a removal party on 23 October 2016 (Fig. 3).
- A mechanical removal approach was employed, as it causes the least amount of distress for the surrounding habitat.

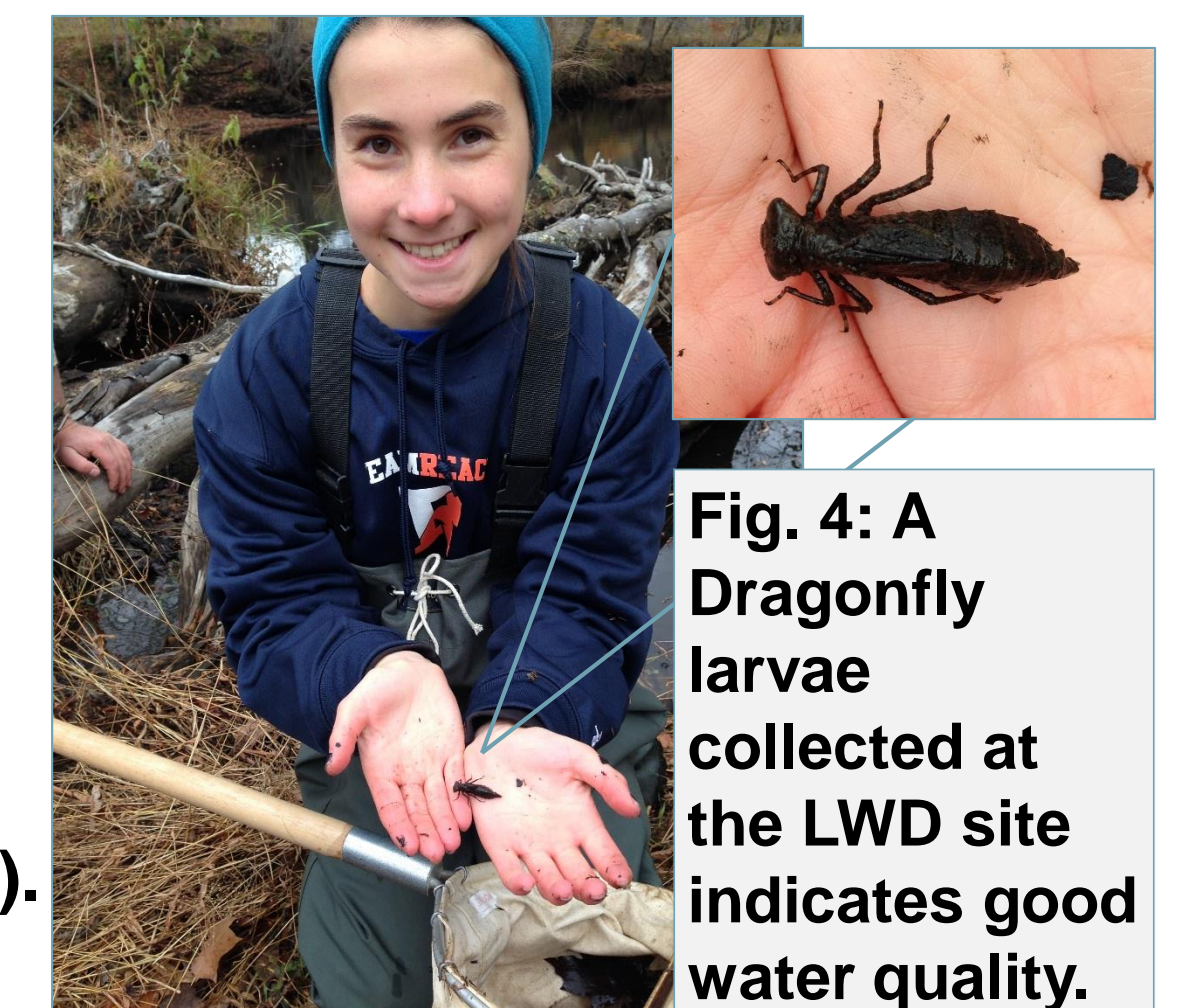
Fig. 4: A Dragonfly larvae collected at the LWD site indicates good water quality.

- Test strips for pH and ammonia
- Chromatography testing in a local chemistry lab for chloride, nitrate, and sulfate
- Macroinvertebrate (e.g. aquatic insect) surveys using a net, bucket, and guide table (Fig. 4)

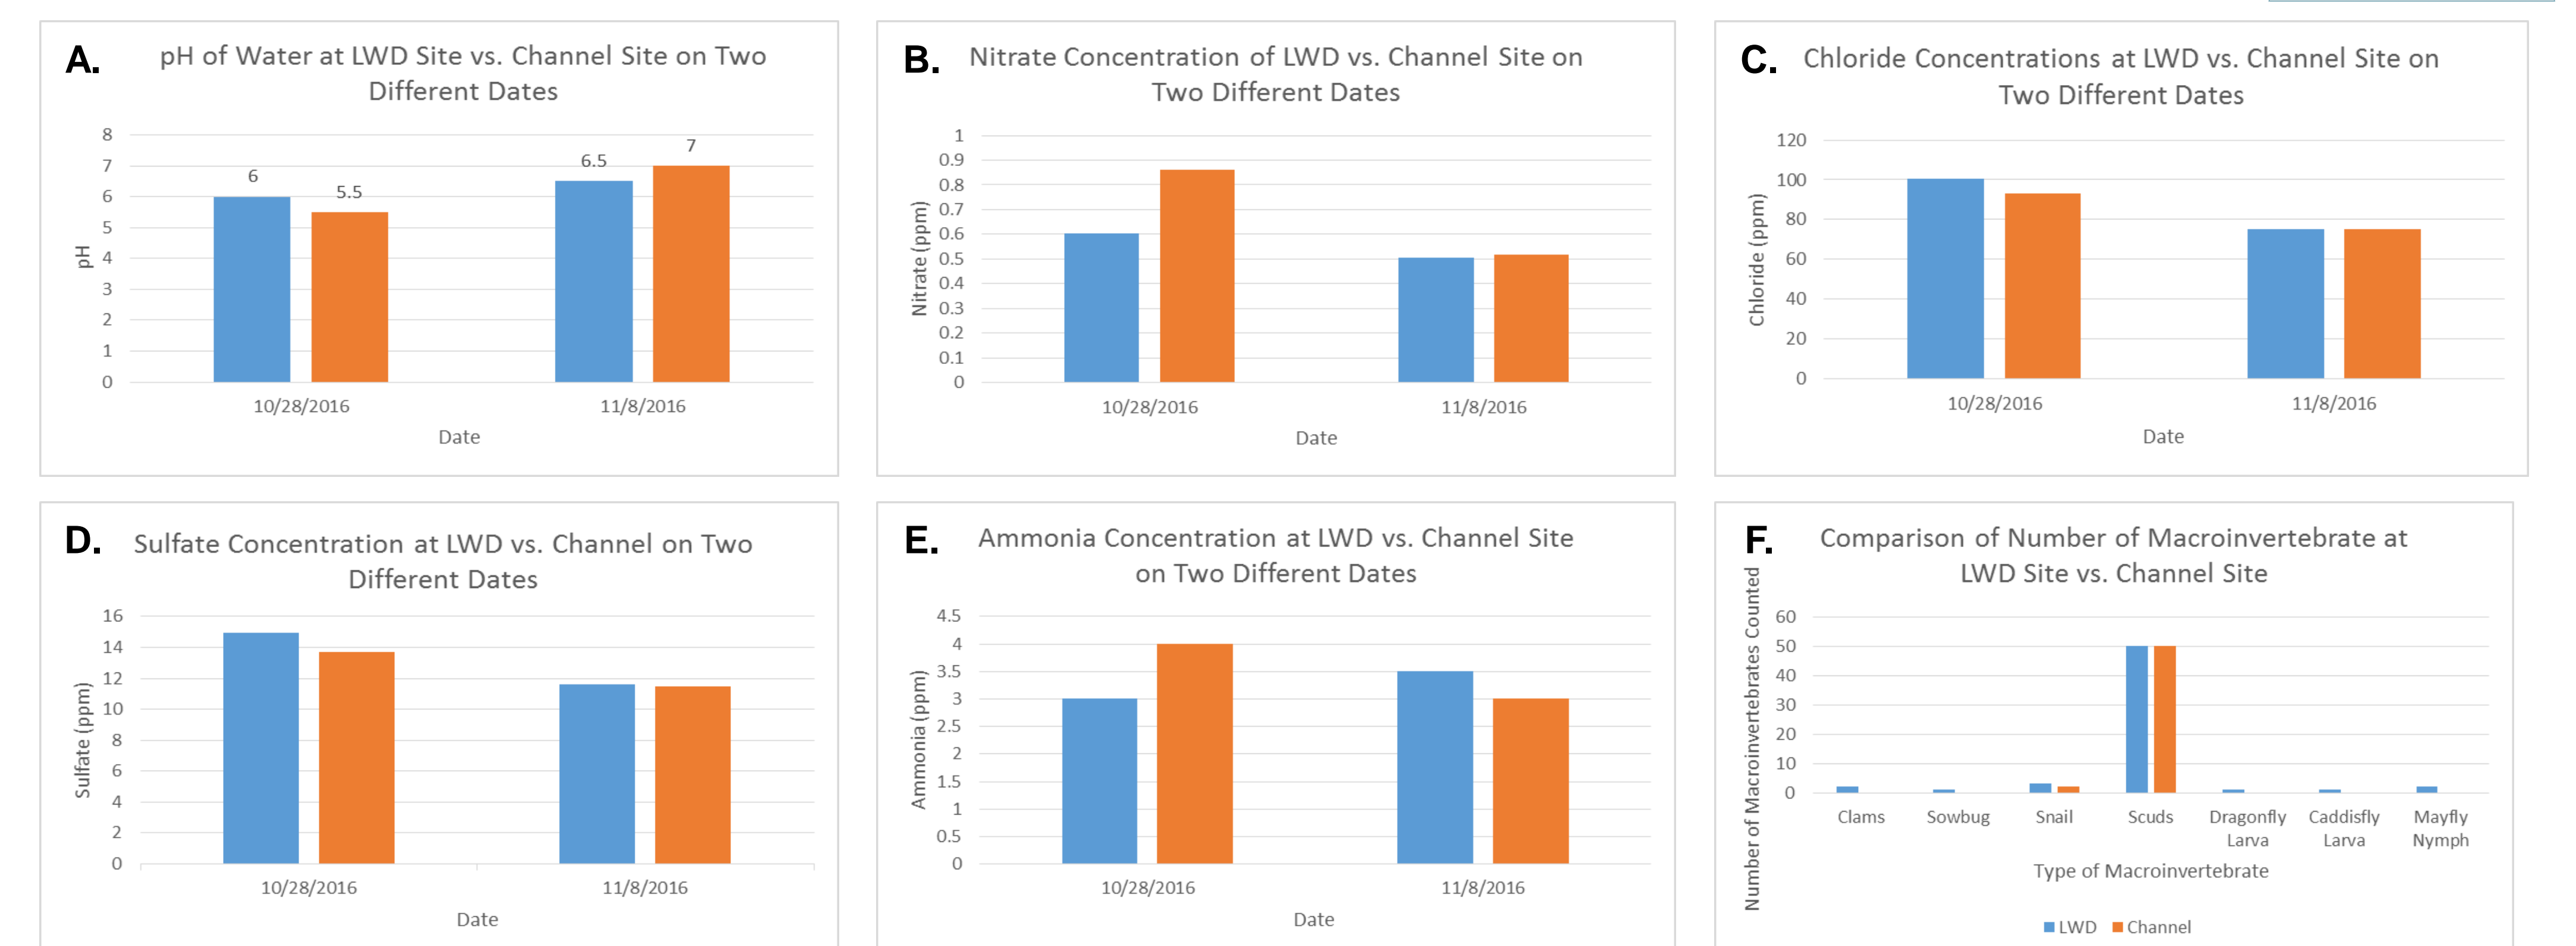
Fig. 5: Differences in (A) pH, (B) nitrate, (C) chloride, (D) sulfate, (E) ammonia, and (F) macroinvertebrates between the LWD (blue) and channel (orange) sites.

- Little difference in ion concentration or pH between LWD and channelized sites (Fig. 5A-E).
- Higher chloride levels were found at the earlier testing date due to the road salting.
- Higher biodiversity of macroinvertebrates at the LWD site than the channelized site (Fig. 5F).
